Asbestos Design Data Collection (DDC) 02112019

| Building: | TM Peirce Elementary School | Total Number of Work Areas: | 7 |
| ULCS: | 4380 | Work Area Locations (list areas): | Kitchen/Serving Area in Hallway, Hallway from Building Engineer's Office and Boiler Room to Boy's Restroom, Lunchroom A, Lunchroom B, Main Gym adjacent to Lunchroom B, Room B1 Gymnasium, Lunchroom C |
| Date Inspected: | 10/24/19 | Requested by: | OEMS |

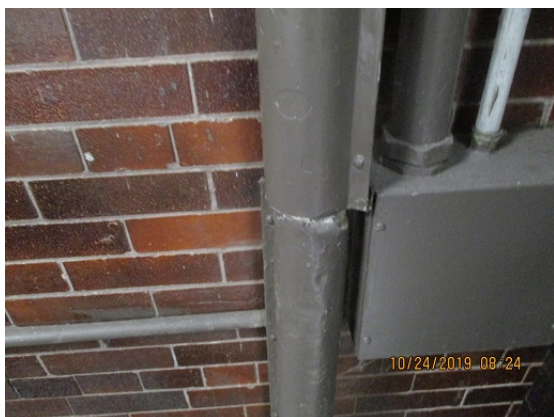
| Scope of Work | | | | | | | | | | | | | | | | |
|---|---|--|---|---|---|---|---|---|---|---|---|---|---|--|---|--|
| Comments: | | Top 3 feet of insulation moves up and down | | | | | | | | | | | | | | |
| Pipe Insulation | Confirmed | 370 LF | 6 LF | 3 LF | No | Yes | Adjacent to oven | Remove | Minor | No | Friable | Boiler Room | 1 | Boiler Room | Full Containment | No |

Photo 1 – Loose Pipe Insulation Close Up

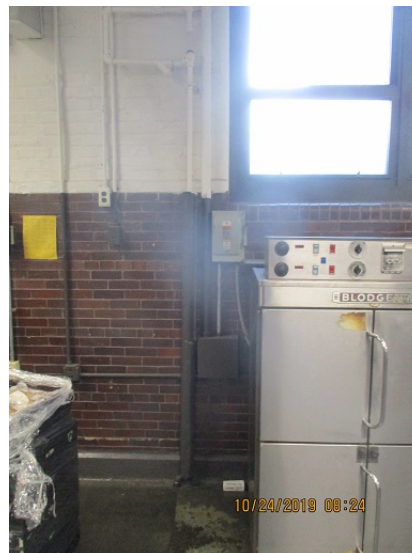
Photo 2 – Loose Pipe Insulation Wide View

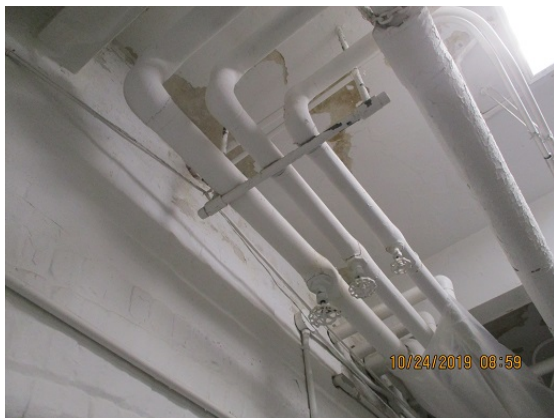
| Scope of Work | | | | | | | | | | | | | | | | |
|---|---|--|---|---|---|---|---|---|---|---|---|---|---|--|---|--|
| Pipe Insulation | Confirmed | 427 LF | 3 LF | 3 LF | No | Yes | 20 cracks and exposed ends throughout | Encapsulate | Minor | No | Friable | N/A | N/A | Boiler Room | N/A | No |

Photo 3 – Cracked Pipe Insulation Close Up 1

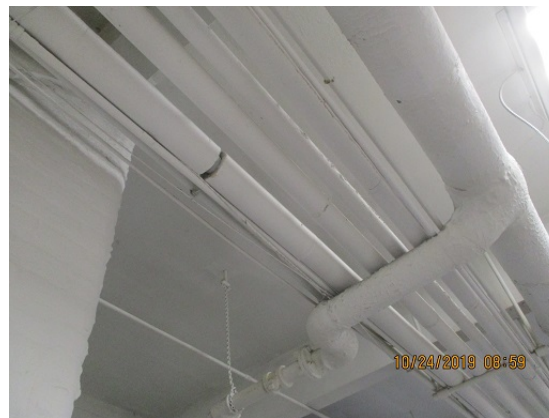
Photo 4 – Exposed Ends Close Up 1

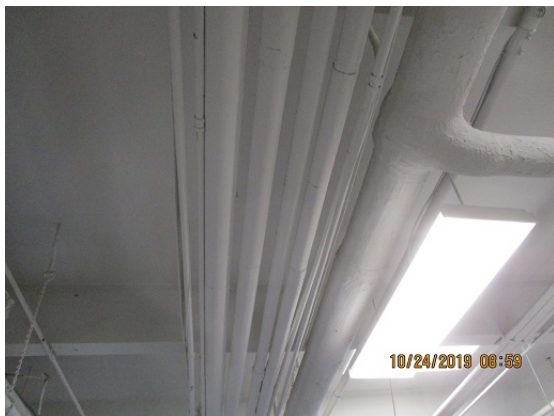
Photo 5 – Cracks and Exposed Ends on Pipe Insulation Close Up 1

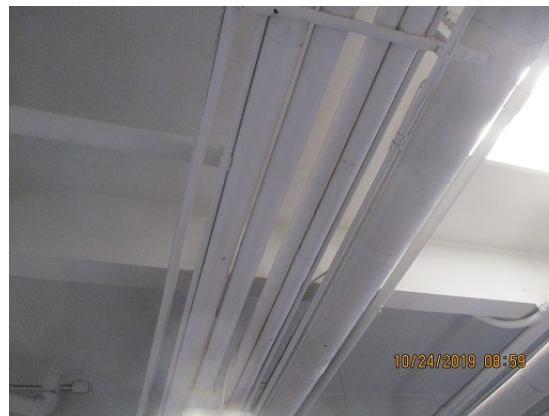
Photo 6 – Cracks and Exposed Ends on Pipe Insulation Close Up 2

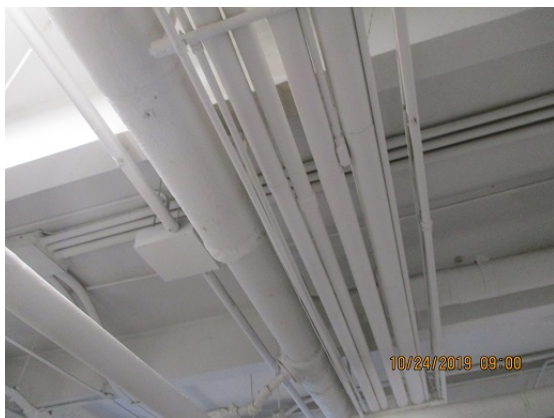
Photo 7 – Cracks and Exposed Ends on Pipe Insulation Close Up 3

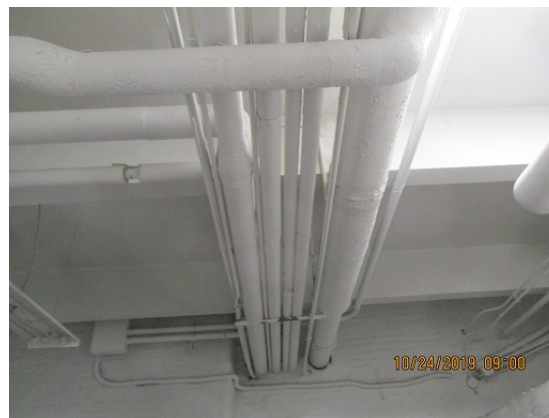
Photo 8 – Cracks and Exposed Ends on Pipe Insulation Close Up 4

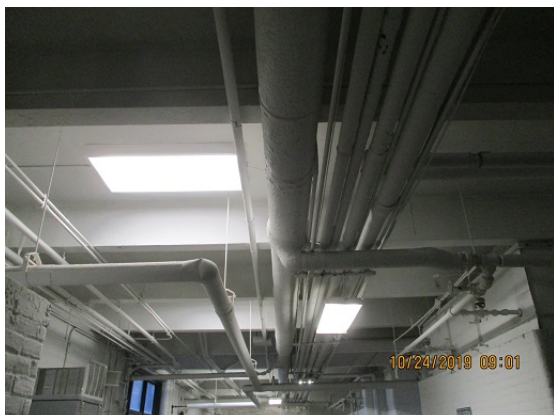
Photo 8 – Cracks and Exposed Ends on Pipe Insulation Wide View 1

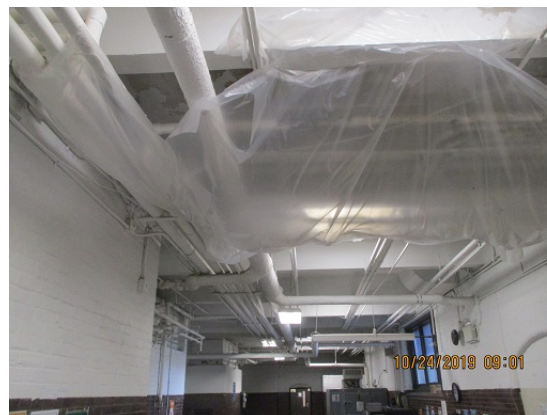
Photo 9 – Cracks and Exposed Ends on Pipe Insulation Wide View 2

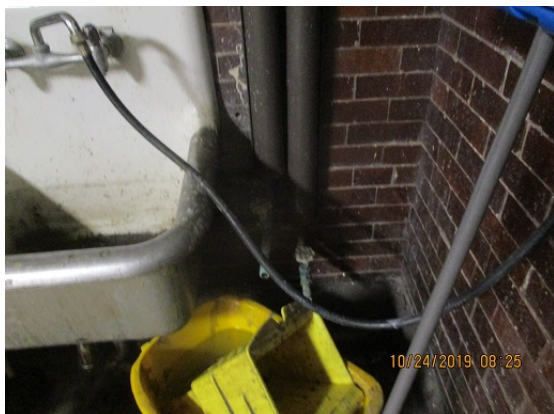
| Scope of Work | | | | | | | | | | | | | | | | |
|---|---|---|---|---|---|---|---|---|---|---|---|---|---|--|---|---|
| Pipe Insulation | Confirmed | 64 LF | 3 LF | 3 LF | No | Yes | 24 cracks and exposed ends throughout | Encapsulate | Minor | No | Friable | N/A | N/A | Boiler Room | N/A | No |

Photo 1 – Exposed Ends Close Up 1

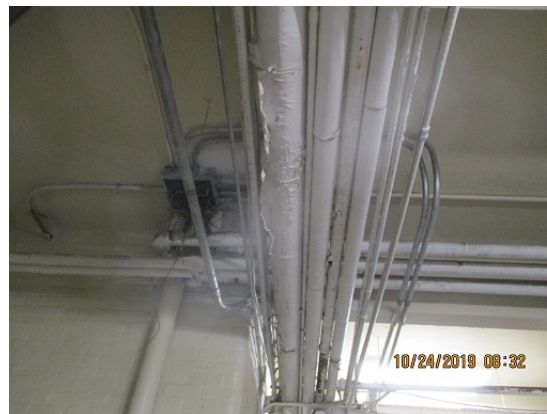
Photo 2 – Cracks and Exposed Ends on Pipe Insulation Close Up 1

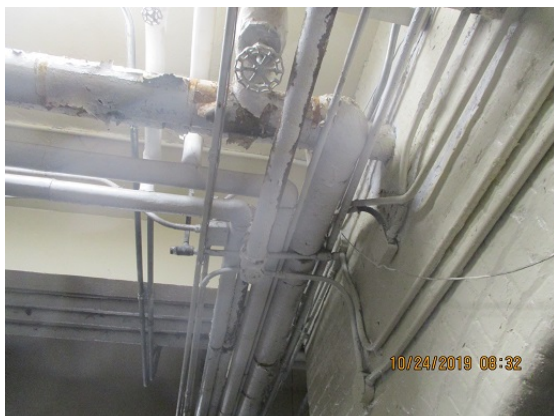
Photo 3 – Cracks and Exposed Ends on Pipe Insulation Close Up 2

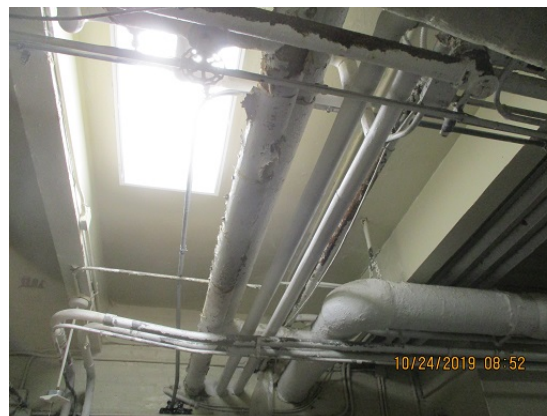
Photo 4 – Cracks and Exposed Ends on Pipe Insulation Close Up 3

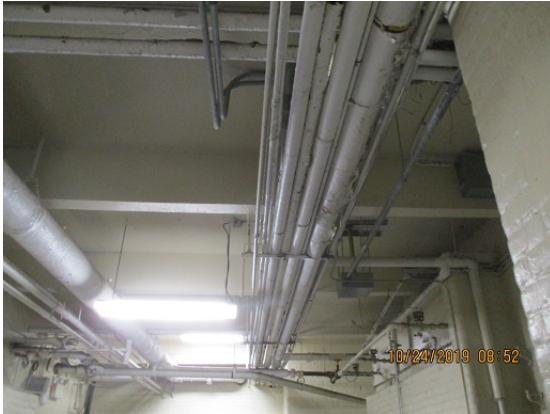
Photo 5 – Cracks and Exposed Ends on Pipe Insulation Close Up 4

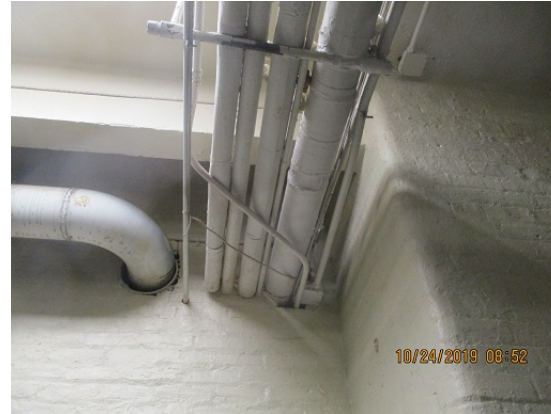
Photo 6 – Cracks and Exposed Ends on Pipe Insulation Close Up 5

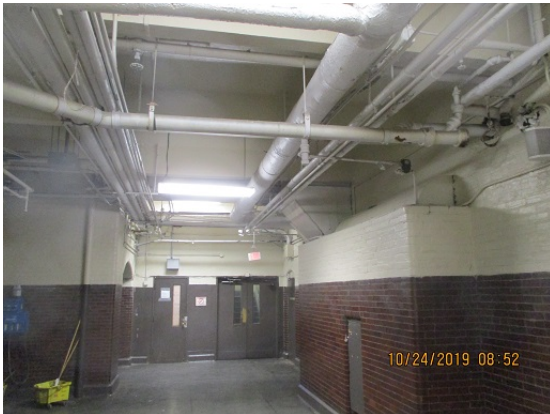
Photo 7 – Cracks and Exposed Ends on Pipe Insulation Wide View

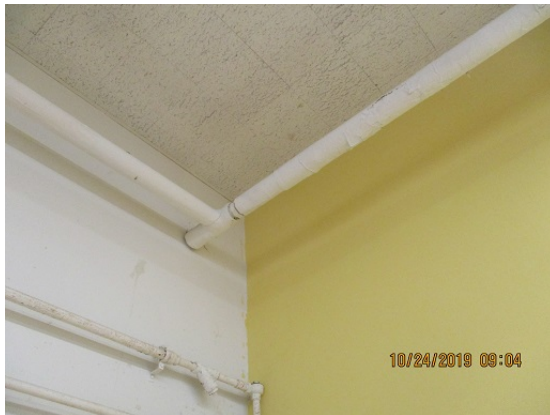
| Scope of Work | | | | | | | | | | | | | | | | |
|---|--|---|--|---|--|---|--|--|--|--|--|---|---|---|---|---|
| Pipe Insulation | Confirmed | 100 LF | 1 LF | 1 LF | No | Yes | 7 cracks and exposed ends throughout | Encapsulate | Incidental | No | Friable | N/A | N/A | Boiler Room | N/A | No |

Photo 1 – Exposed Ends Close Up 1

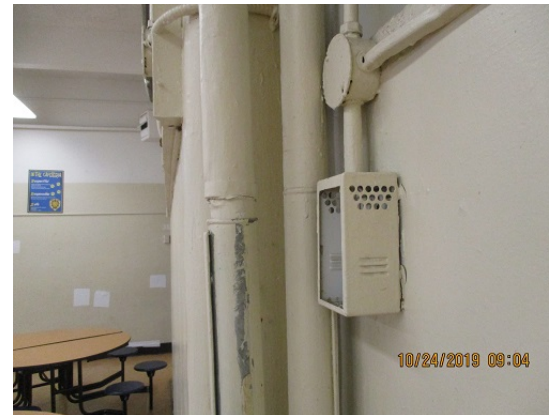
Photo 2 – Cracking Pipe Insulation Close Up 1

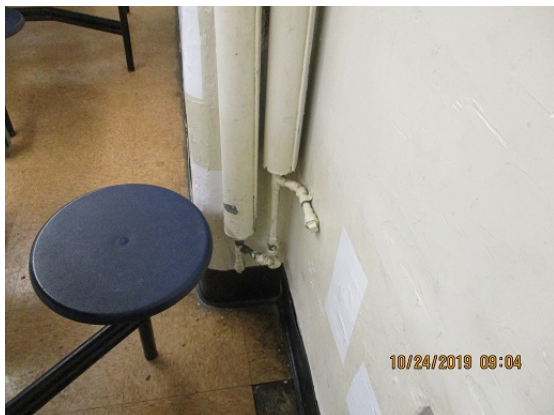
Photo 3 – Exposed Ends Close Up 2

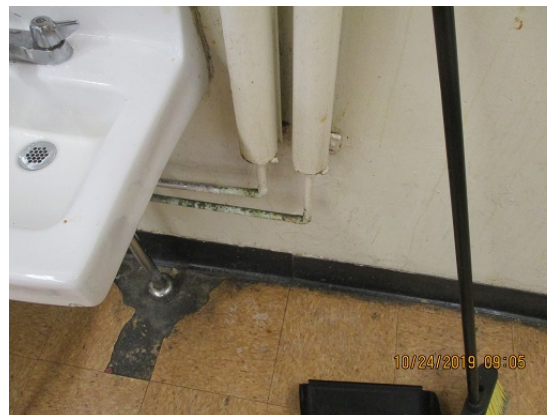
Photo 4 - Exposed Ends Close Up 3

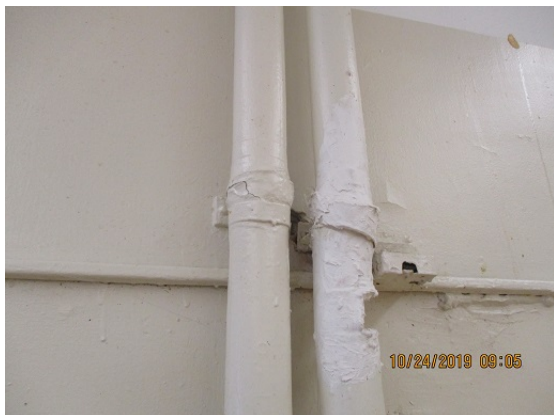
Photo 5 – Cracking Pipe Insulation Close Up 2

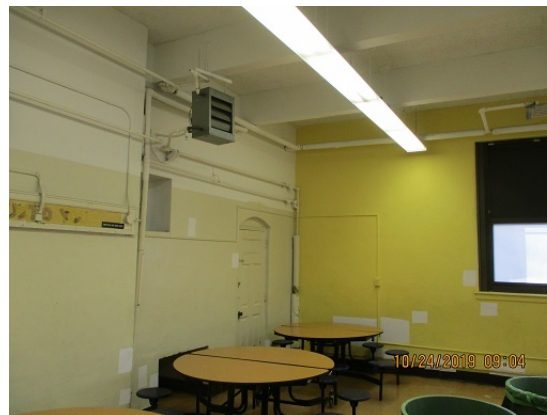
Photo 6 – Exposed Ends and Cracking Insulation Wide View 1

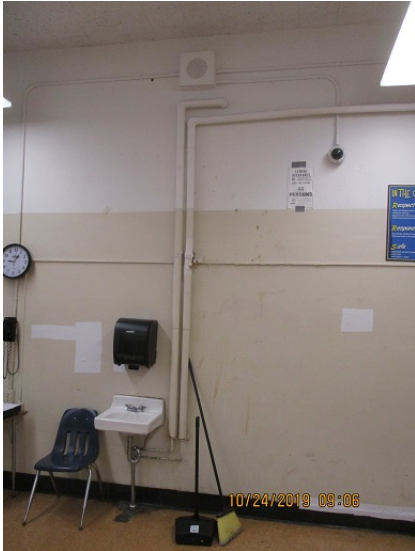
Photo 7 – Exposed Ends and Cracking Insulation Wide View 2

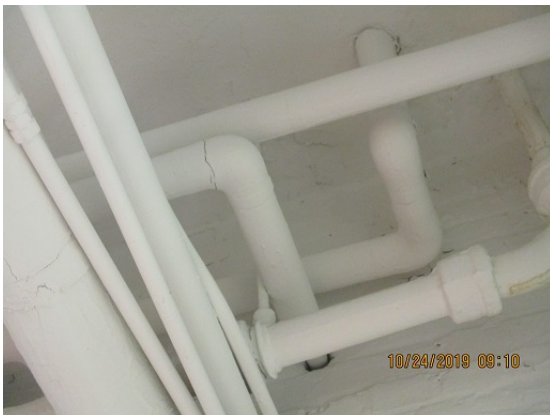
| Work Location #: | 4 | | | | | | | | | | | | | | | |
|---|--|---|--|---|--|---|--|--|--|--|--|---|---|---|---|---|
| Pipe Insulation | Confirmed | 22 LF | 1 LF | 1 LF | No | Yes | 5 cracks and exposed ends throughout | Encapsulate | Incidental | No | Friable | N/A | N/A | Boiler Room | N/A | No |

Photo 1 – Cracked Pipe Insulation Close Up 1

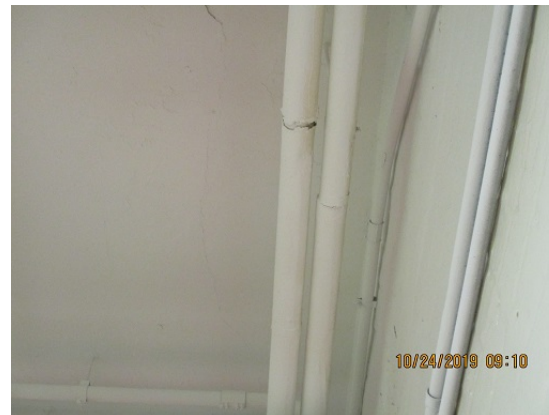
Photo 2 – Cracked Pipe Insulation Close Up 2

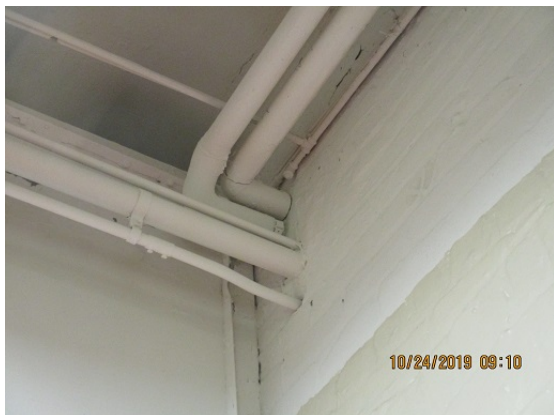
Photo 3 – Cracked Pipe Insulation Close Up 3

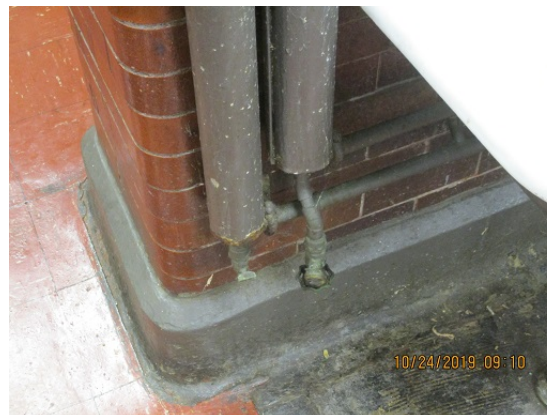
Photo 4 - Exposed Ends Close Up 1

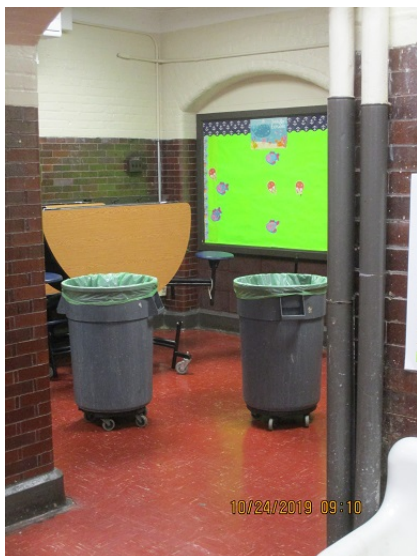
Photo 5 – Cracking and Exposed Ends Wide View 1

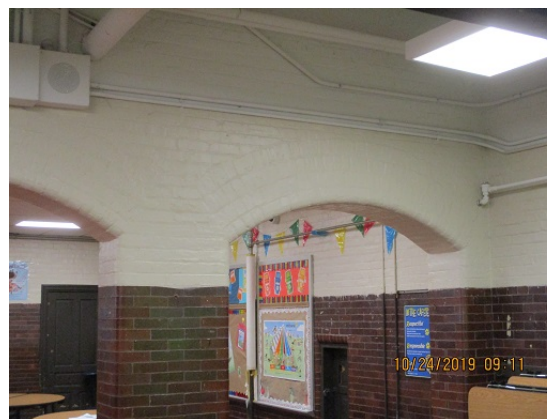
Photo 6 – Cracking and Exposed Ends Wide View 2

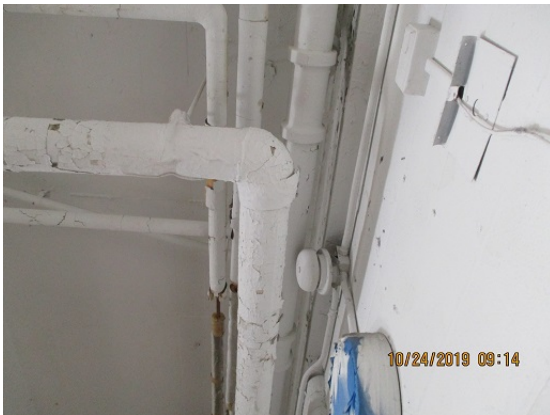
| Work Location #: | 5 | | | | | | | | | | | | | | | |
|---|--|---|--|---|--|---|--|--|--|--|--|---|---|---|---|---|
| Pipe Insulation | Confirmed | 50 LF | <1 LF | <1 LF | No | Yes | 3 cracks and exposed ends throughout | Encapsulate | Incidental | No | Friable | N/A | N/A | Boiler Room | N/A | No |

Photo 1 – Cracking Pipe Insulation Close Up 1

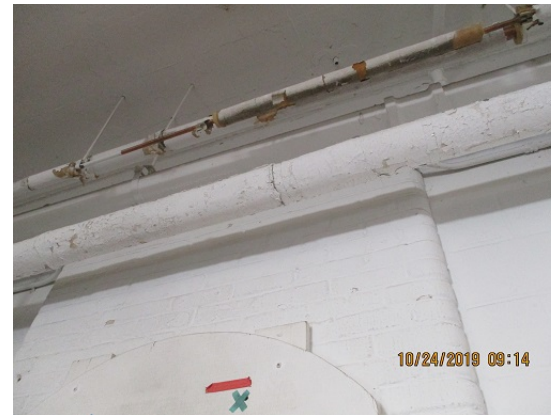
Photo 2 – Cracking Pipe Insulation Close Up 2

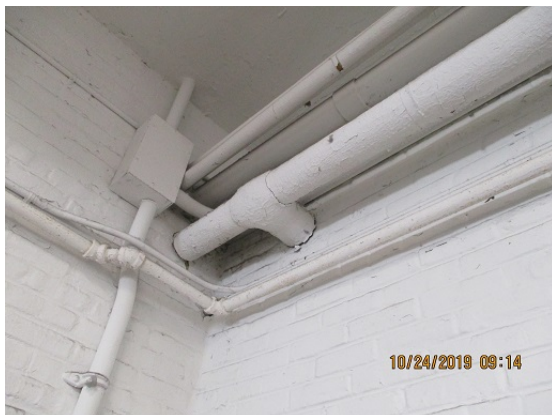
Photo 3 – Cracking Pipe Insulation Close Up 3

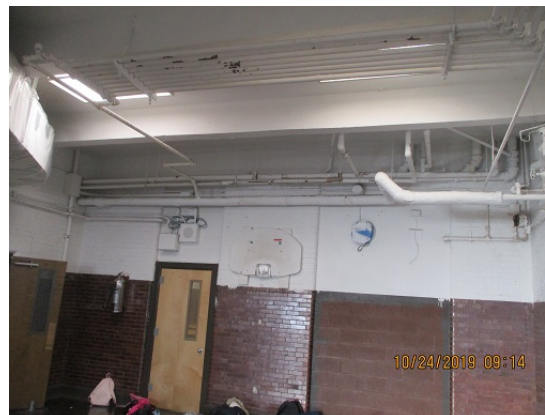
Photo 4 – Cracking Pipe Insulation Wide View

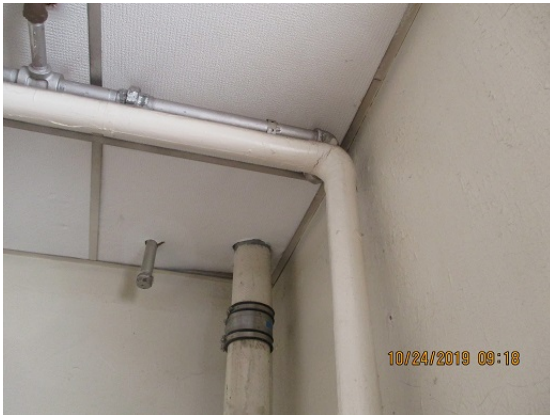
| Work Location #: | | 6 | | | | | | | | | | | | | | |
|---|---|---|---|---|---|---|---|---|---|---|---|---|---|--|---|--|
| Pipe Insulation | Confirmed | 41 LF | <1 LF | <1 LF | No | Yes | 3 cracks and exposed ends throughout | Encapsulate | Incidental | No | Friable | N/A | N/A | Boiler Room | N/A | No |

Photo 1 – Cracking Pipe Insulation Close Up

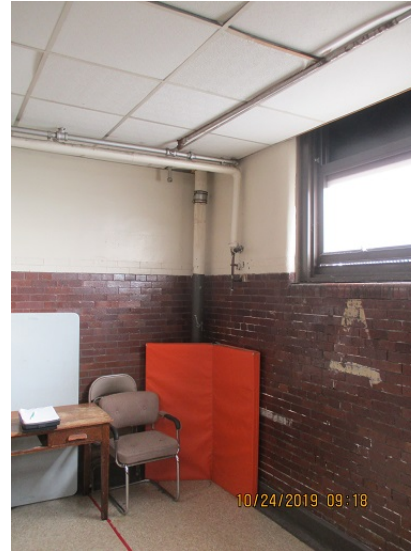
Photo 2 – Cracking Pipe Insulation Wide View

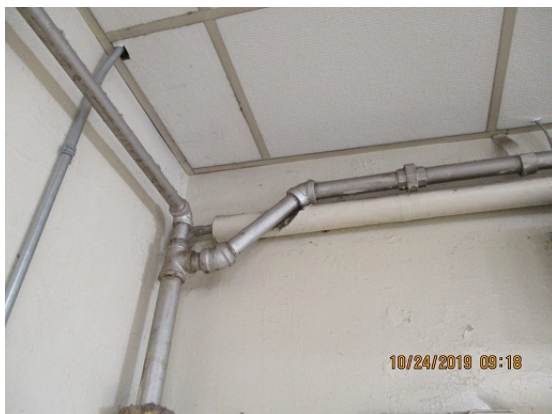
Photo 3 – Exposed Ends Close Up

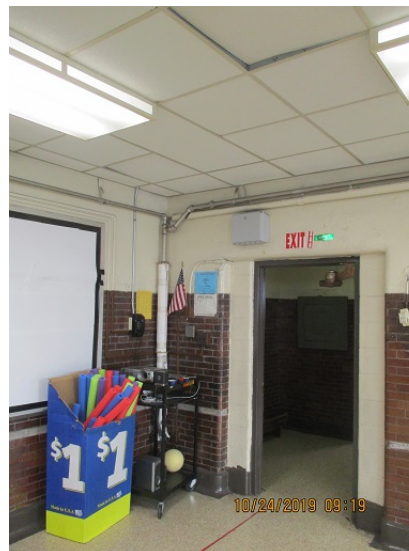
Photo 4 – Exposed Ends Wide View
